Exhibit C: Survey Result Map

OLDS Status and Sampling Results

Map 8

HRG Survey and Sampling Results

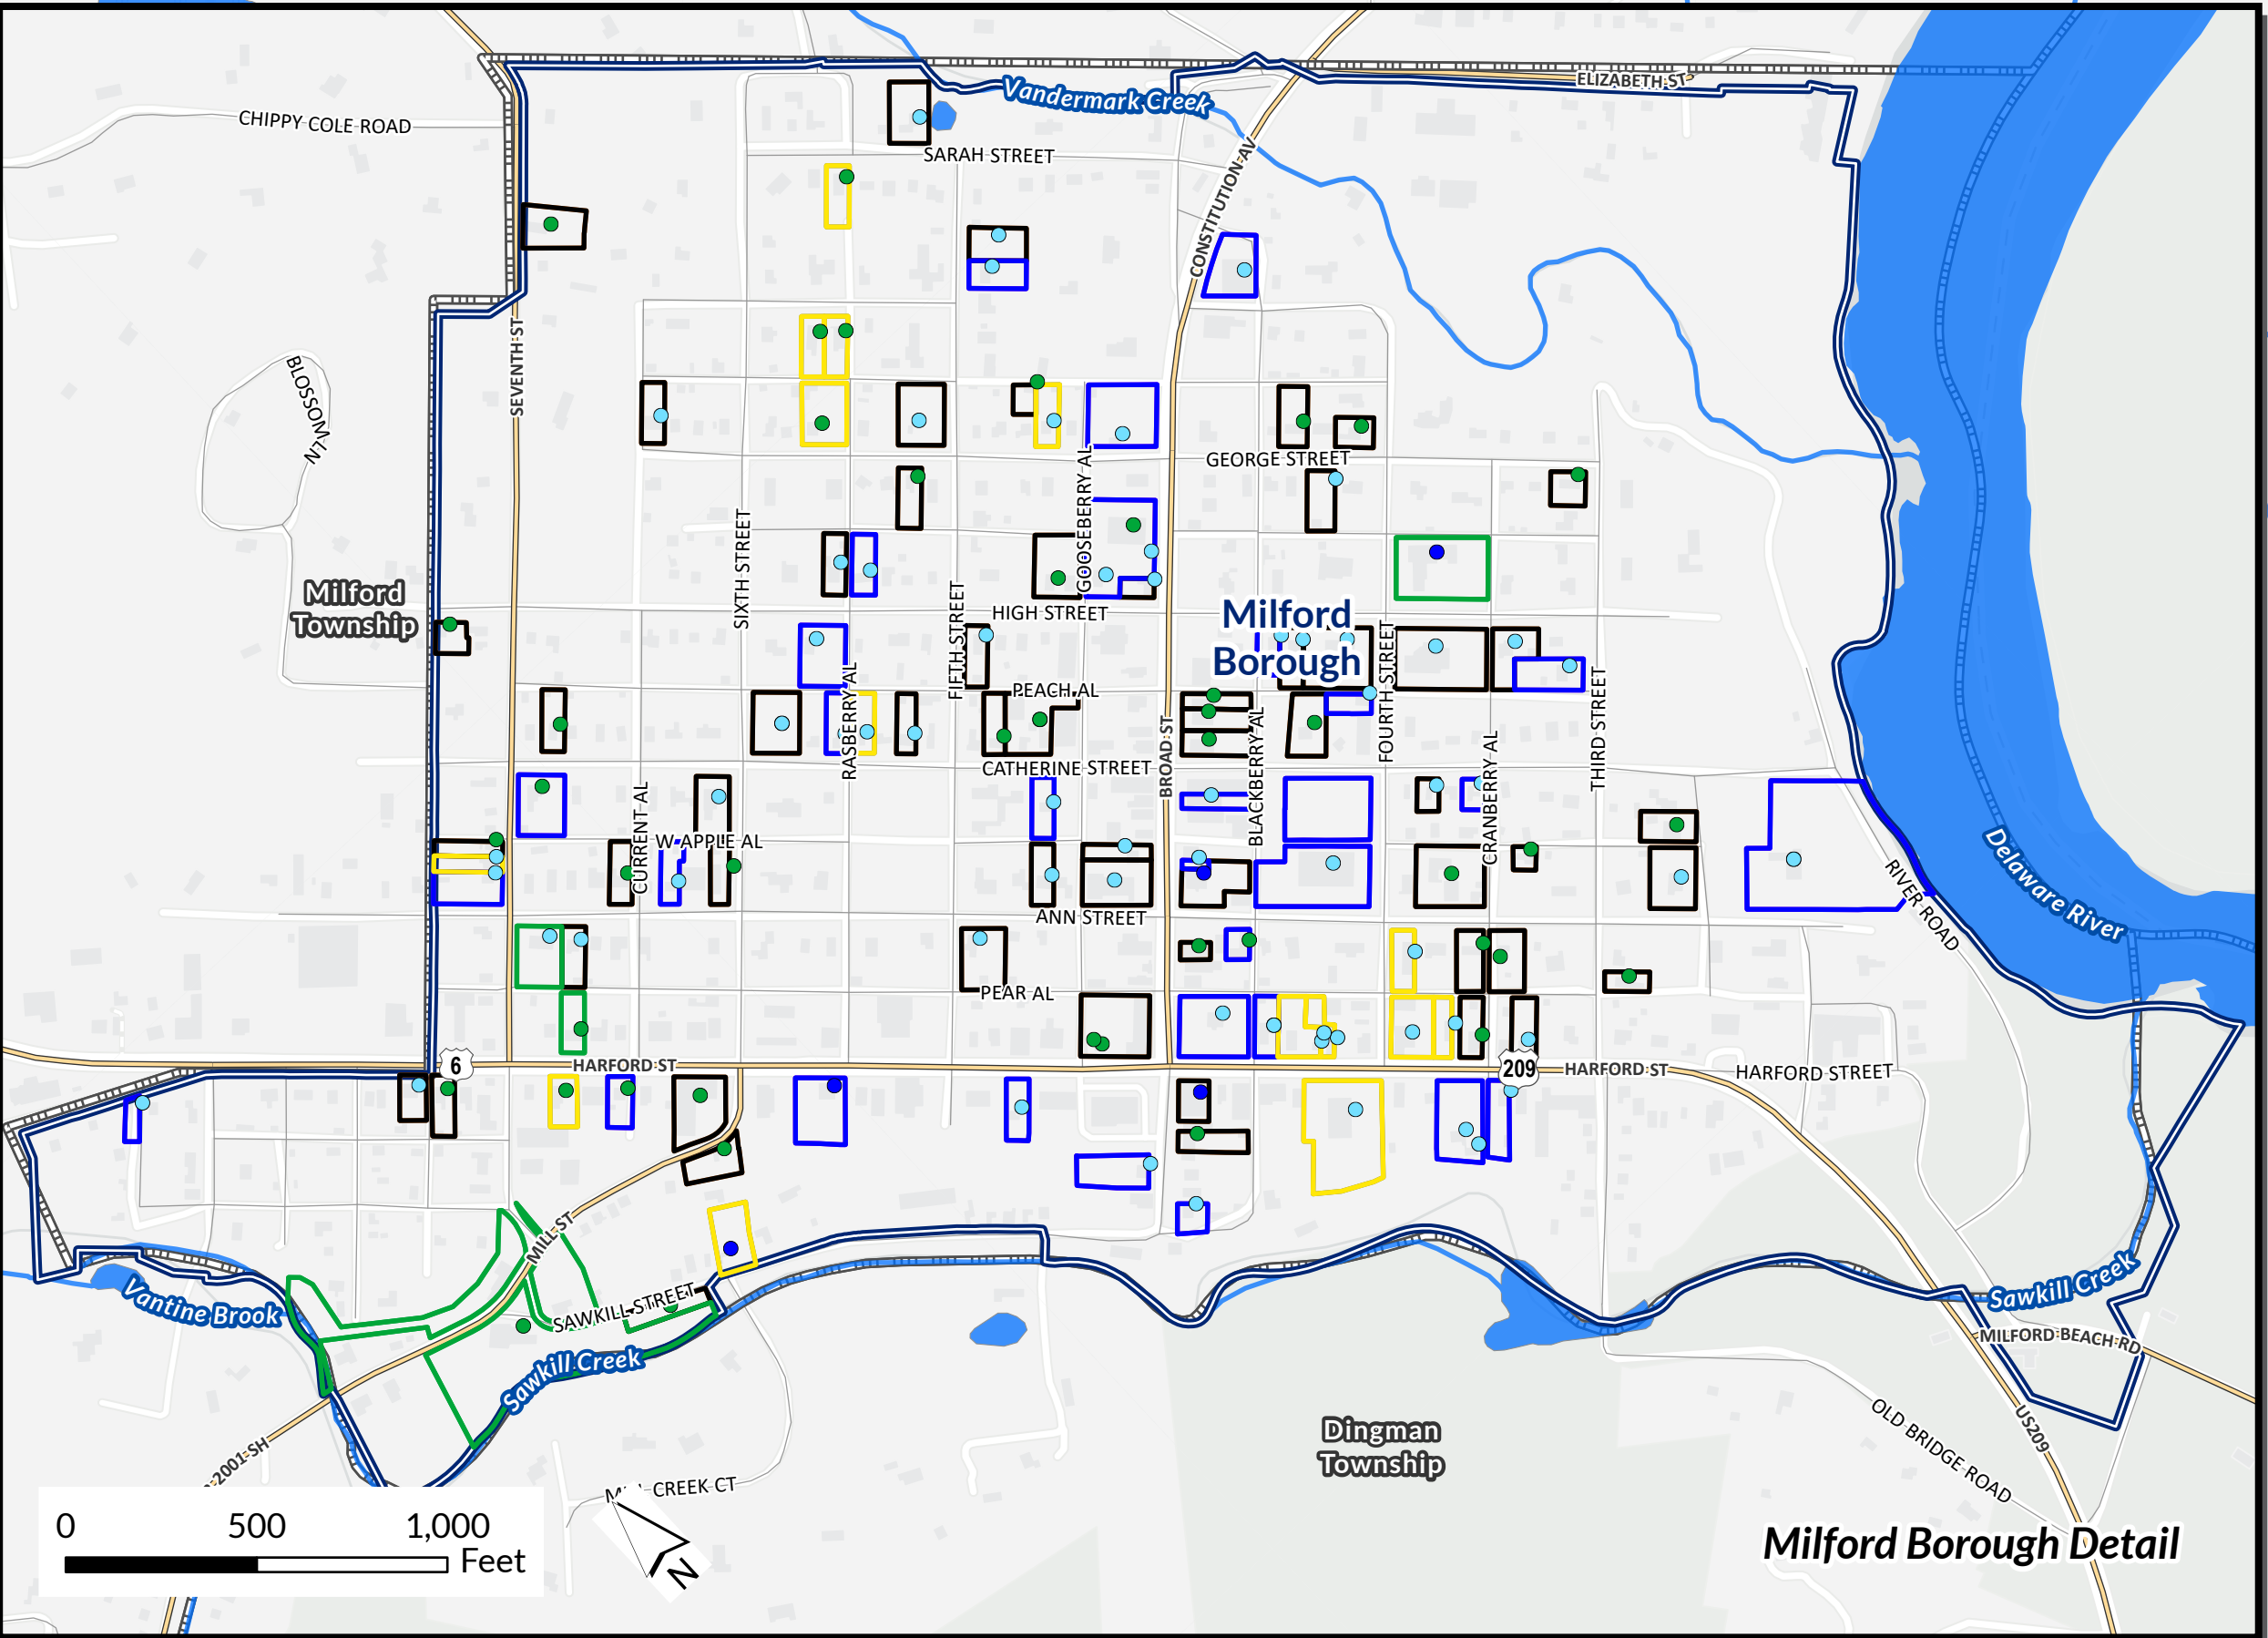
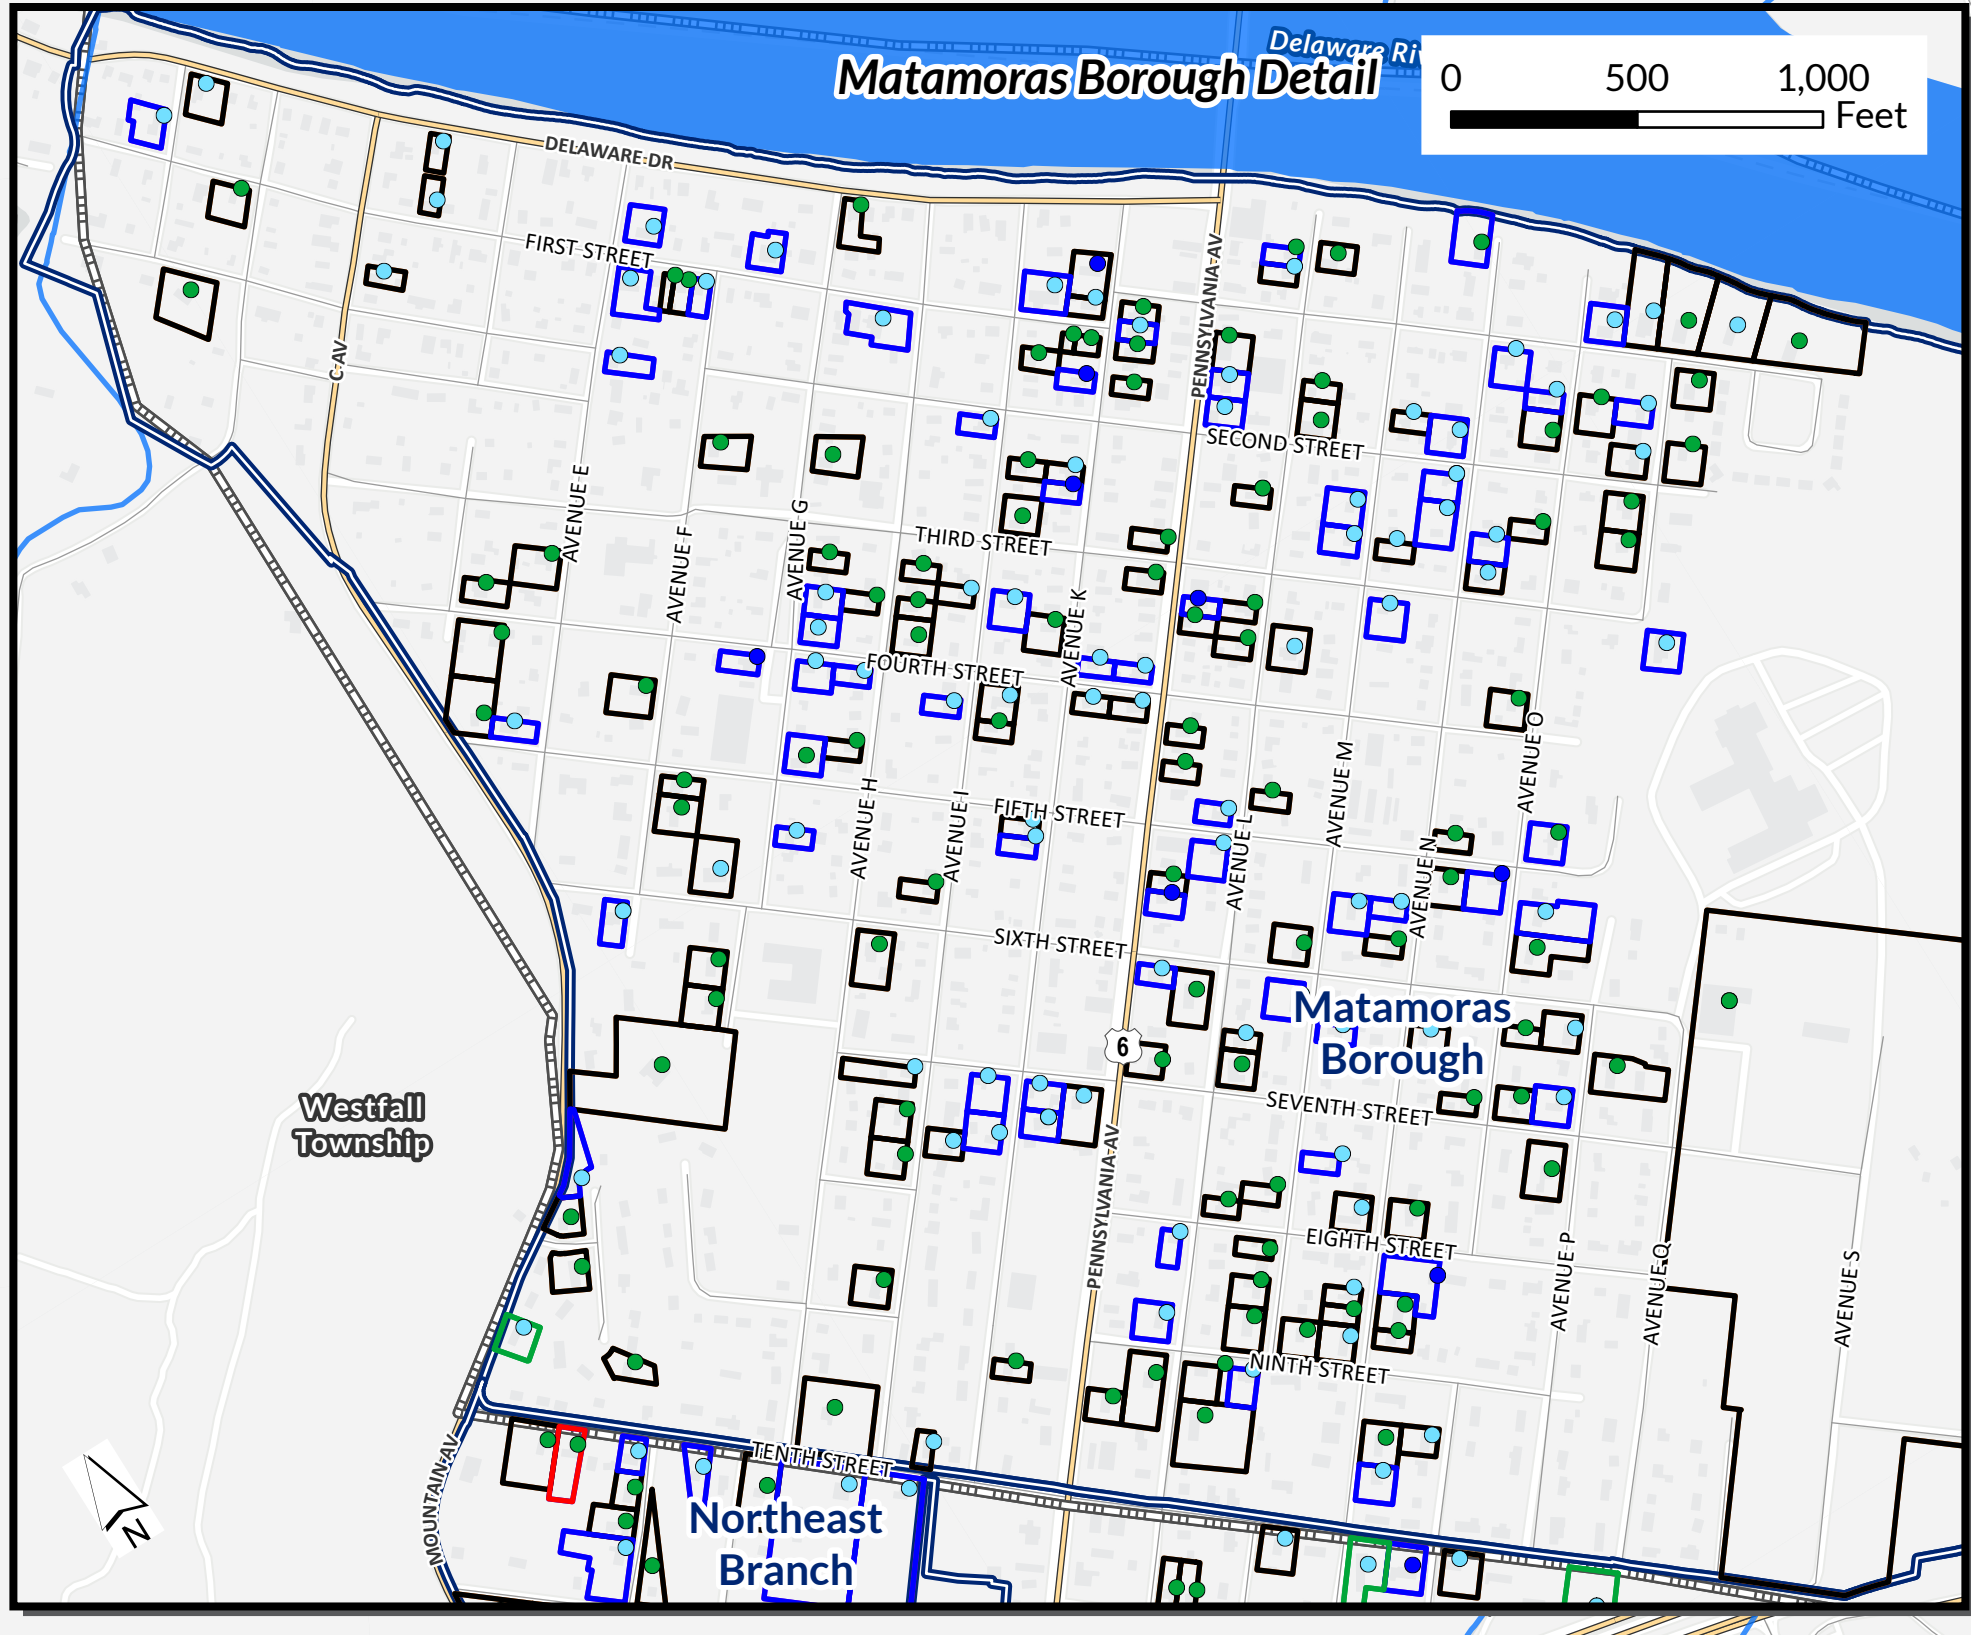
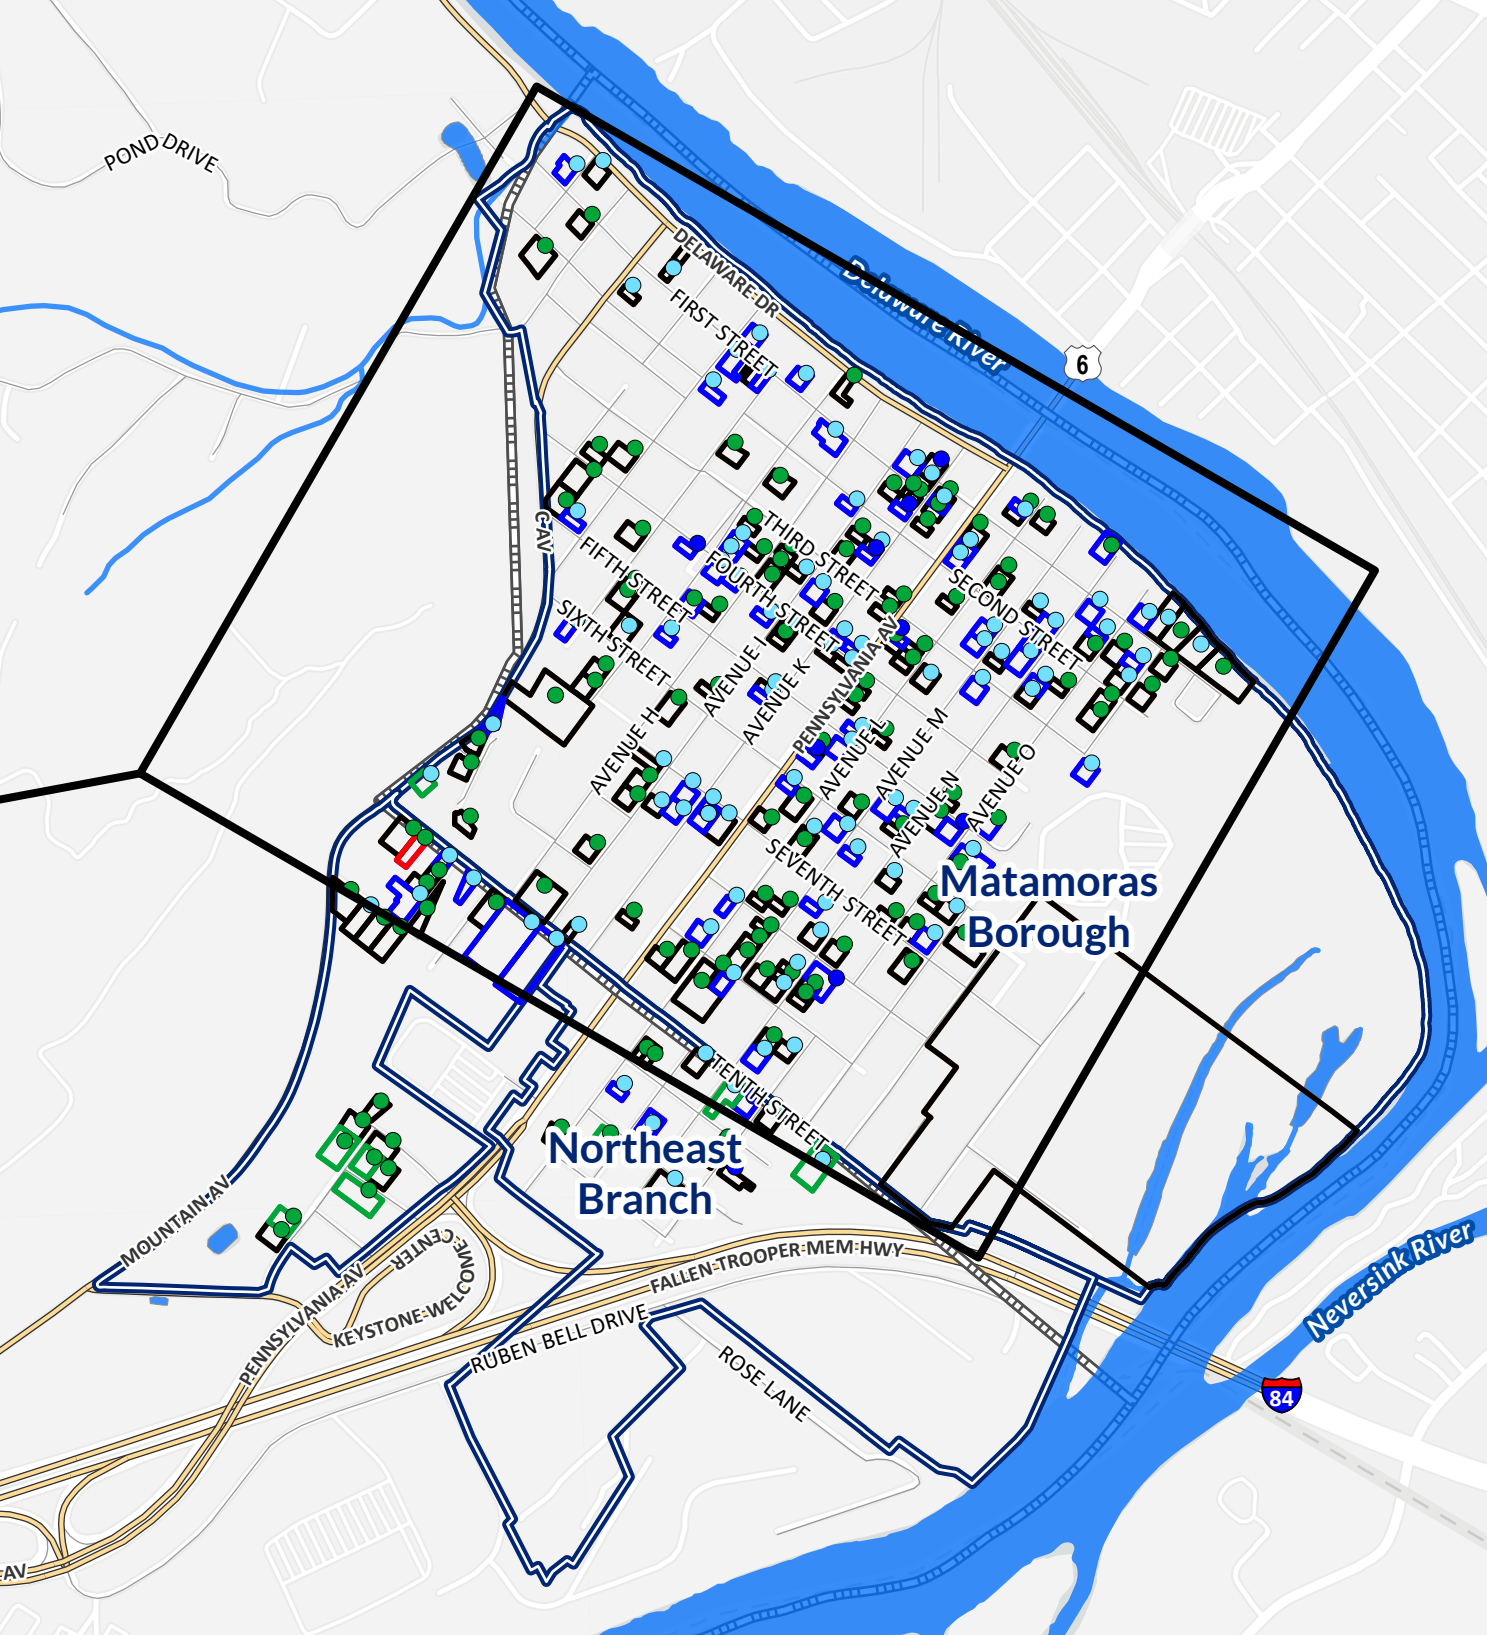
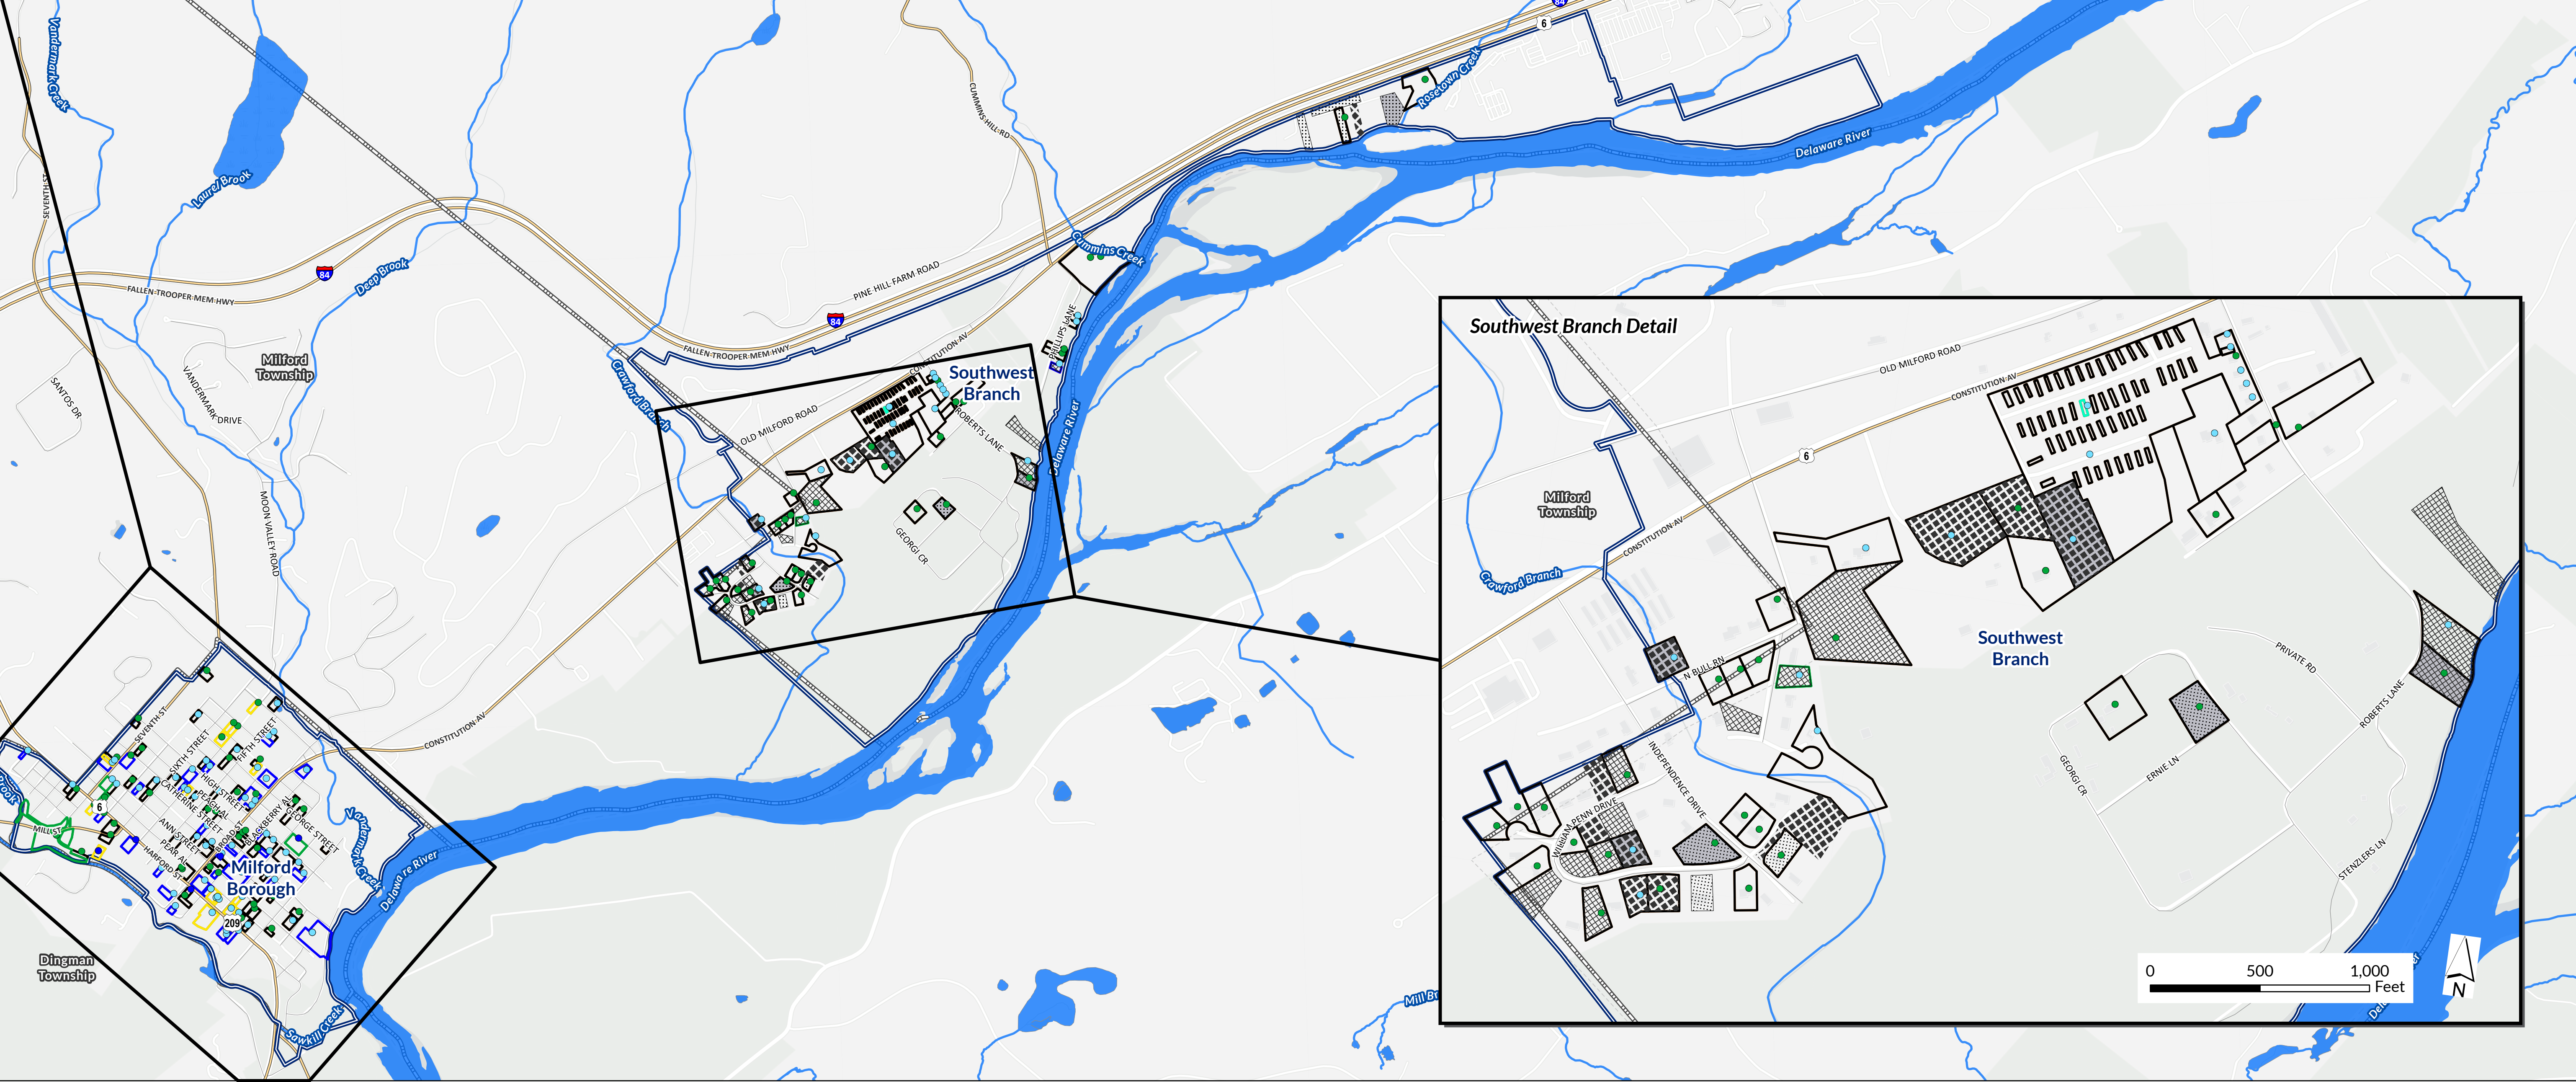
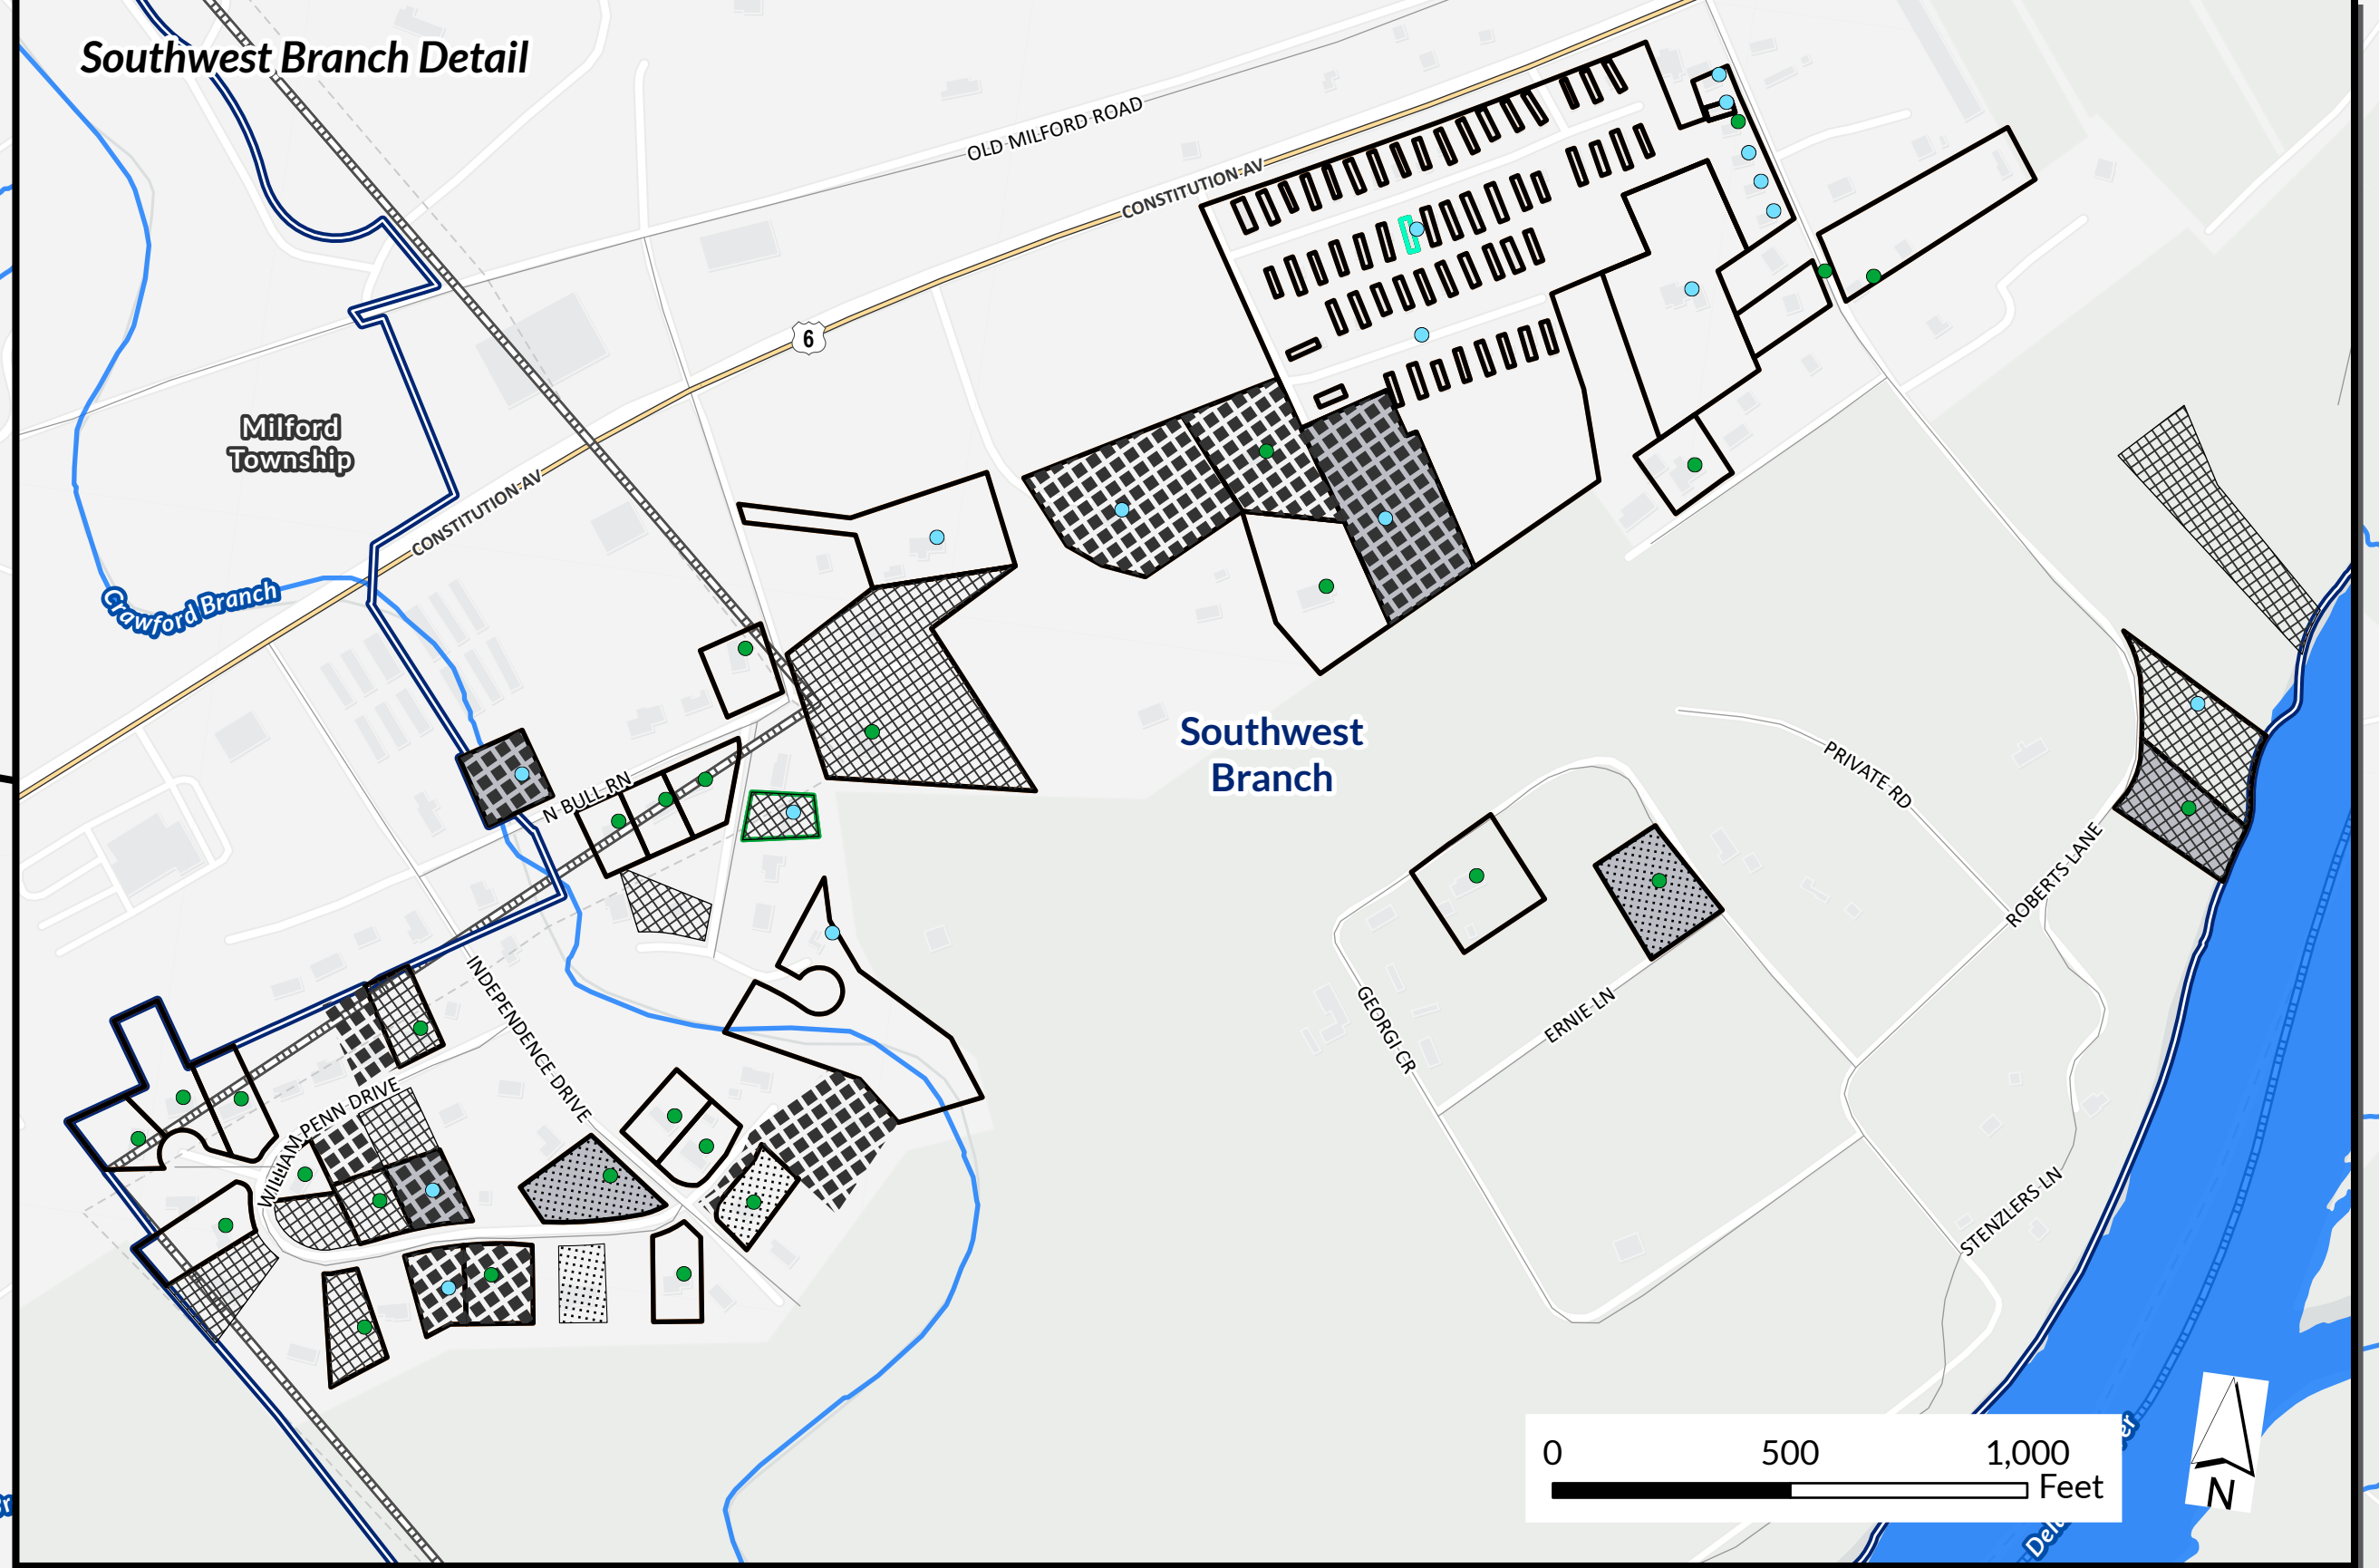
On-Lot Malfunction Status

- No Malfunction (208)
- Suspected (187)
- Confirmed (16)

Well Water Nitrate-Nitrite (mg/L)

- < 1 mg/L (11)
- < 2.5 mg/L (13)
- Not Detected (8)

Well Water (Total Coliform)

- Present (7)

OLDS Type

- Septic Tank (254)
- Cesspool (105)
- Other (15)
- Elevated Sand Mound (13)
- Community System (1)
- Dry Well (1)
